Bridge Deck Cracking MDT 313162

Presentation Summary

- Introduction and Background on Bridge Deck Cracking
- Research Plan:
 - Item 4.1 – Literature Review
 - Item 4.4a – Field Inspections
 - Item 4.4b – Bridge Deck Instrumentation
 - Item 4.5a – Laboratory Evaluations
 - Item 4.5b – Finite Element Modeling
- WJE's Recommendations

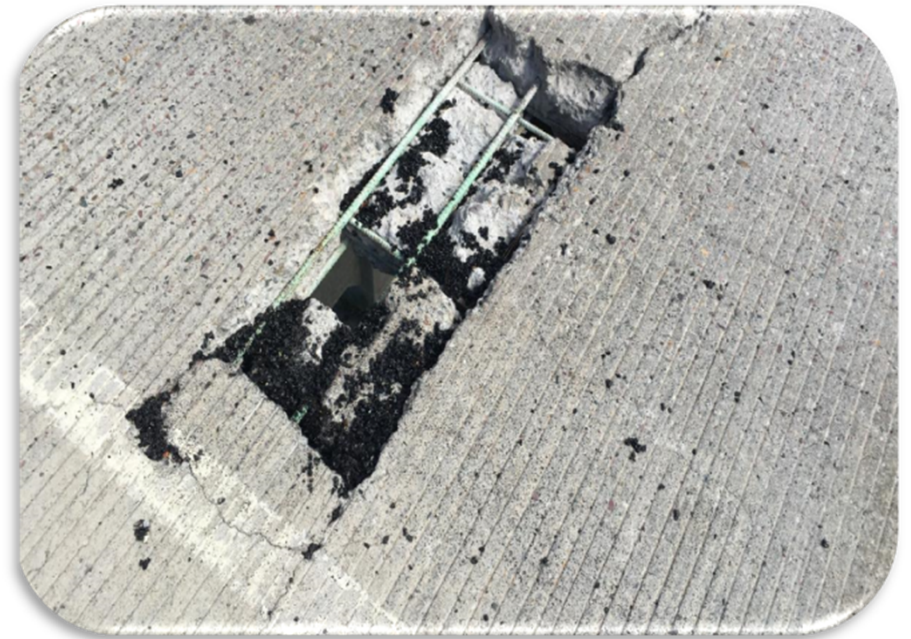
- WJE issued a report in April 2017 and found:
 - Closely spaced transverse cracks on numerous bridges in western Montana
 - Generally wider at the surface
 - Very early age development of the cracks
 - In some cases, through deck penetrations developed

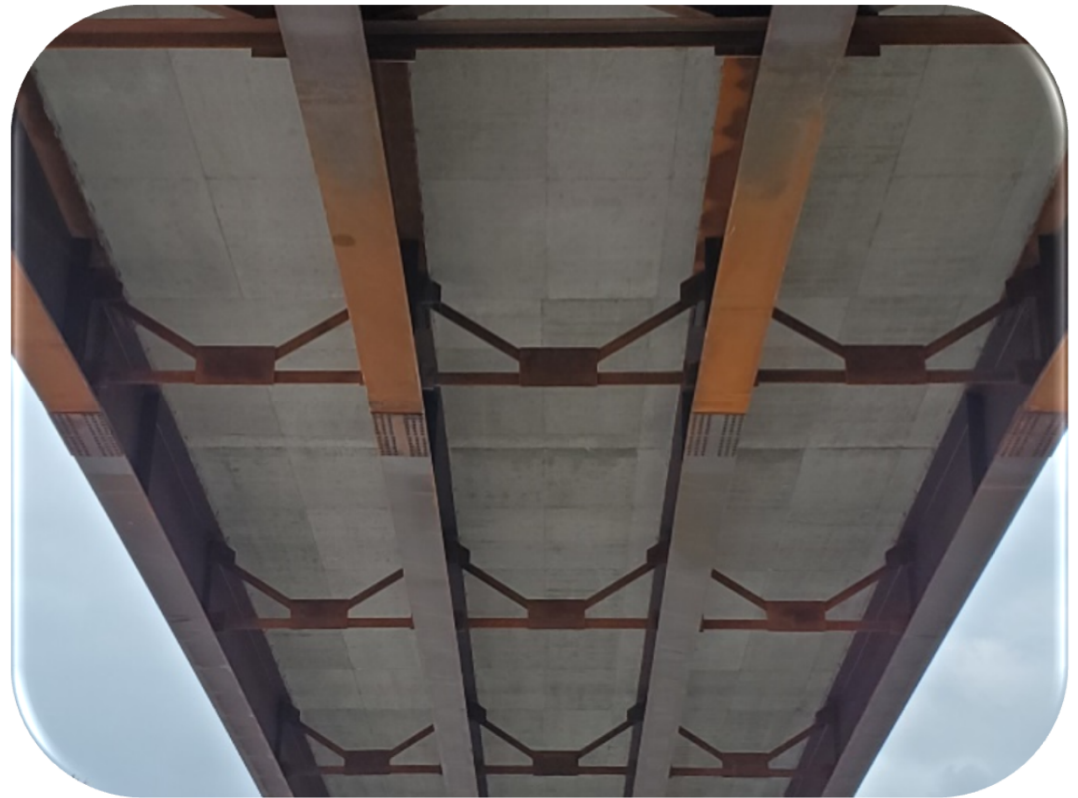
Bonner Bridge – Phase 2 (WB)

- Overall Visual Rating = 1

Placement #	Crack Density (ft/ft2)	Crack Severity (mil*ft/ft2)
1	0.04	0.19
2	0.04	0.19
3	0.03	0.17
4	0.02	0.10
5	0.05	0.23
All	0.03	0.17

- Cracks very difficult to see
- Cracks less than 10 mils

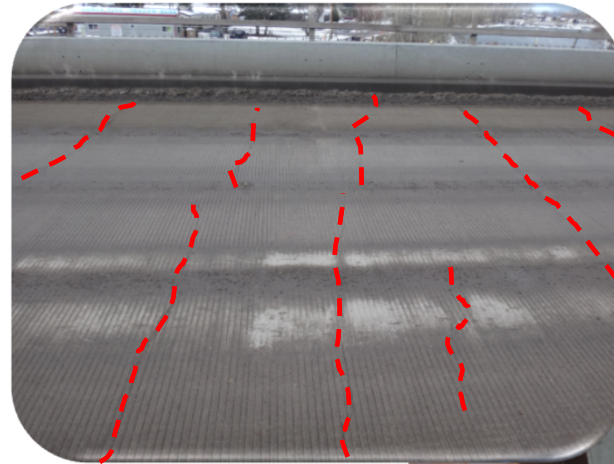
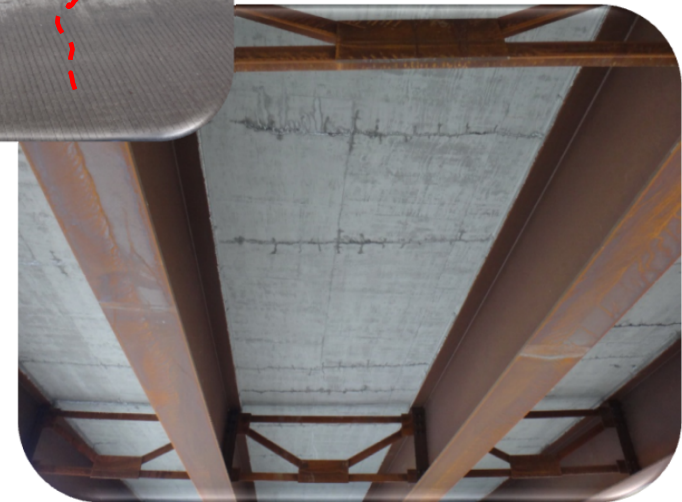
Russell Street Bridge – Phase 1 (NB)

- Overall Visual Rating = 3

Placement #	Crack Density (ft/ft ²)	Crack Severity (mil*ft/ft ²)
1	0.27	6.95
2	0.23	6.62
3	0.21	3.48
4	0.28	3.99
5	0.30	3.63
All	0.26	4.88

- Frequent transverse cracks, 15 to 25 mils

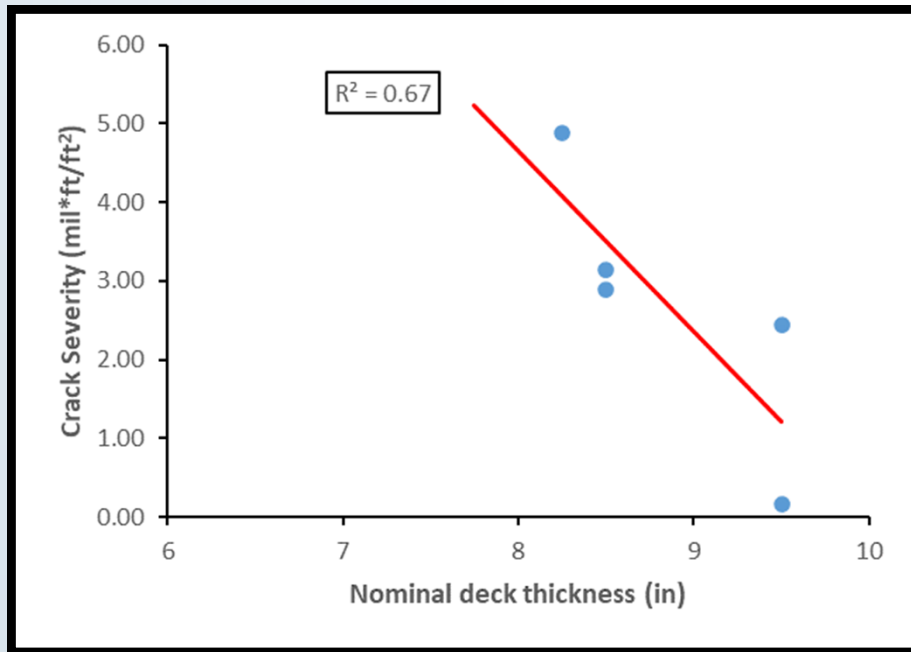
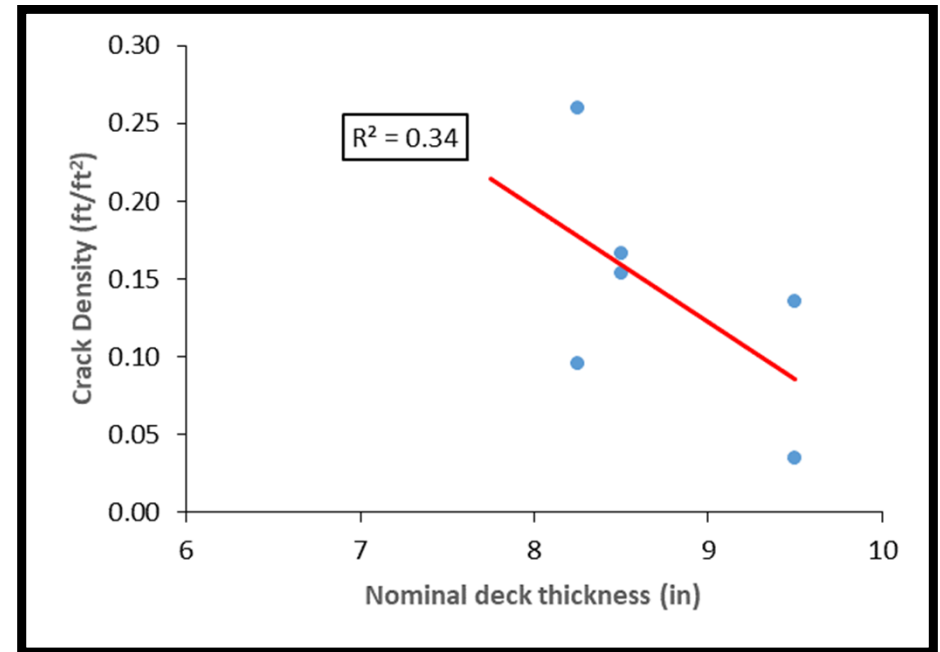
- Cracking appears to be less severe in decks with greater deck thicknesses.

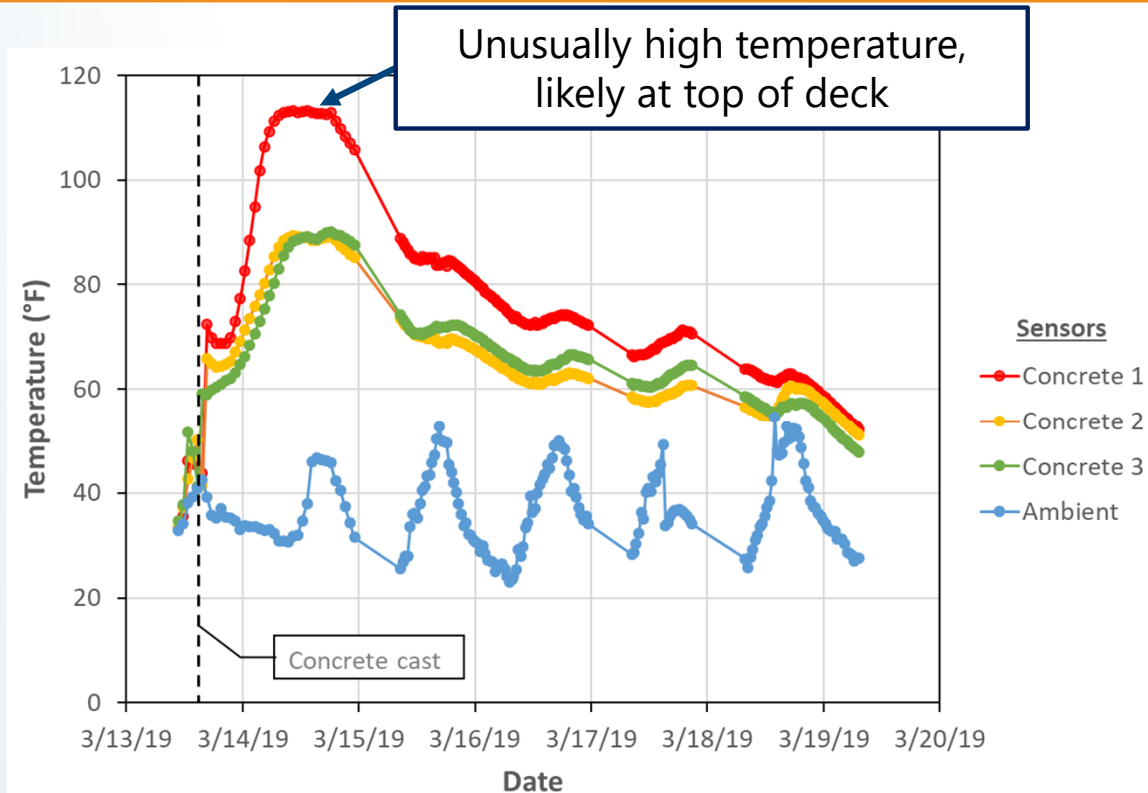
Curing with Heating on Top of Deck

Curing temperature data with heating hoses on top of concrete. Russell Street Bridge Phase I (NB), Placement 1, sensor location 3.

- The placement of concrete during the winter months, actively heated from the top, is likely a contributing factor to transverse cracking severity at Russel Street Phase I (potentially Phase II as well).
- Alternatively, Rarus/Silver Bow Creek Structure, Bridge D, was cast in the winter but heated from the bottom, including the steel girders, and exhibited very little transverse deck cracking.

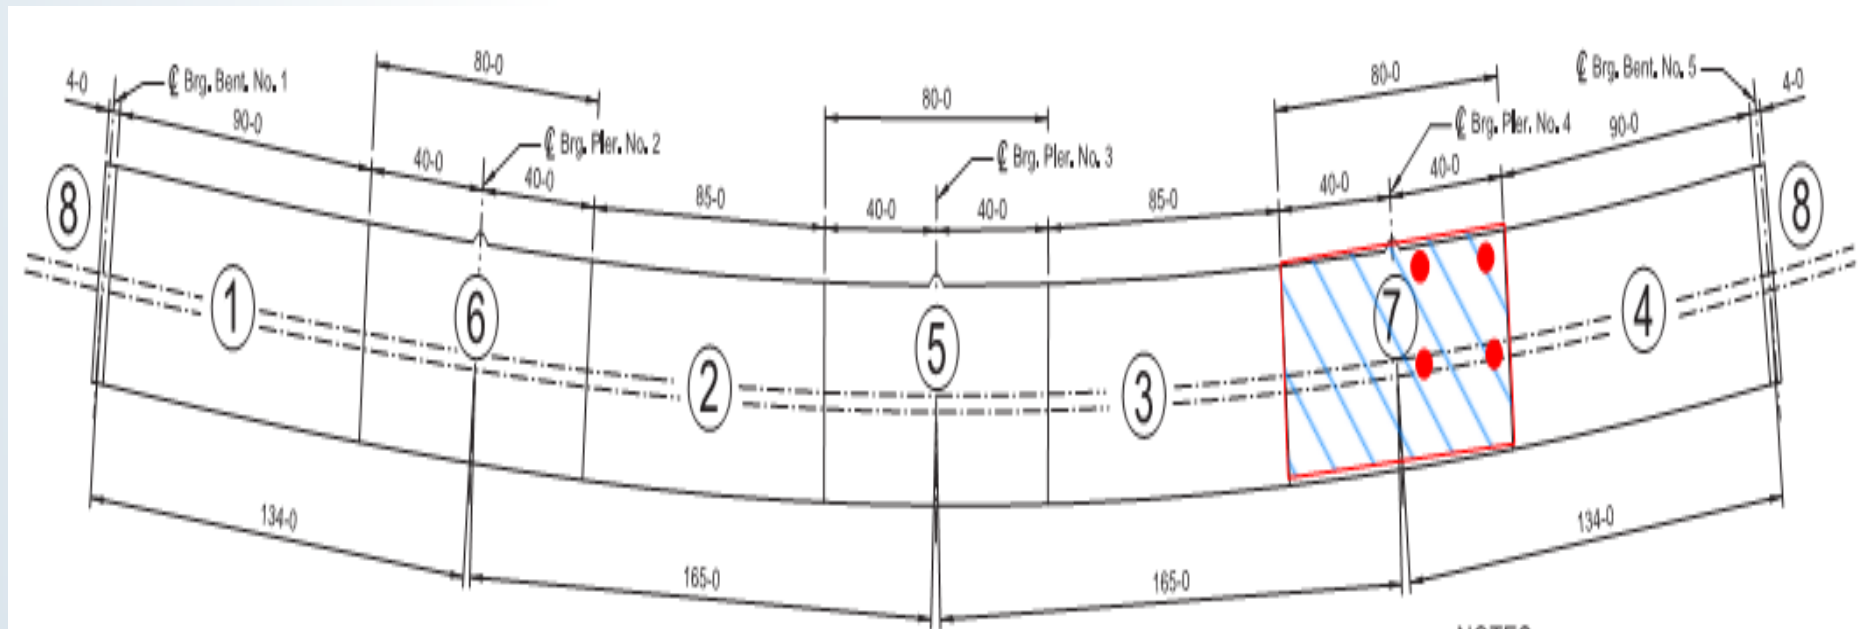
Instrumentation Plan

Placement 7 was selected for instrumentation

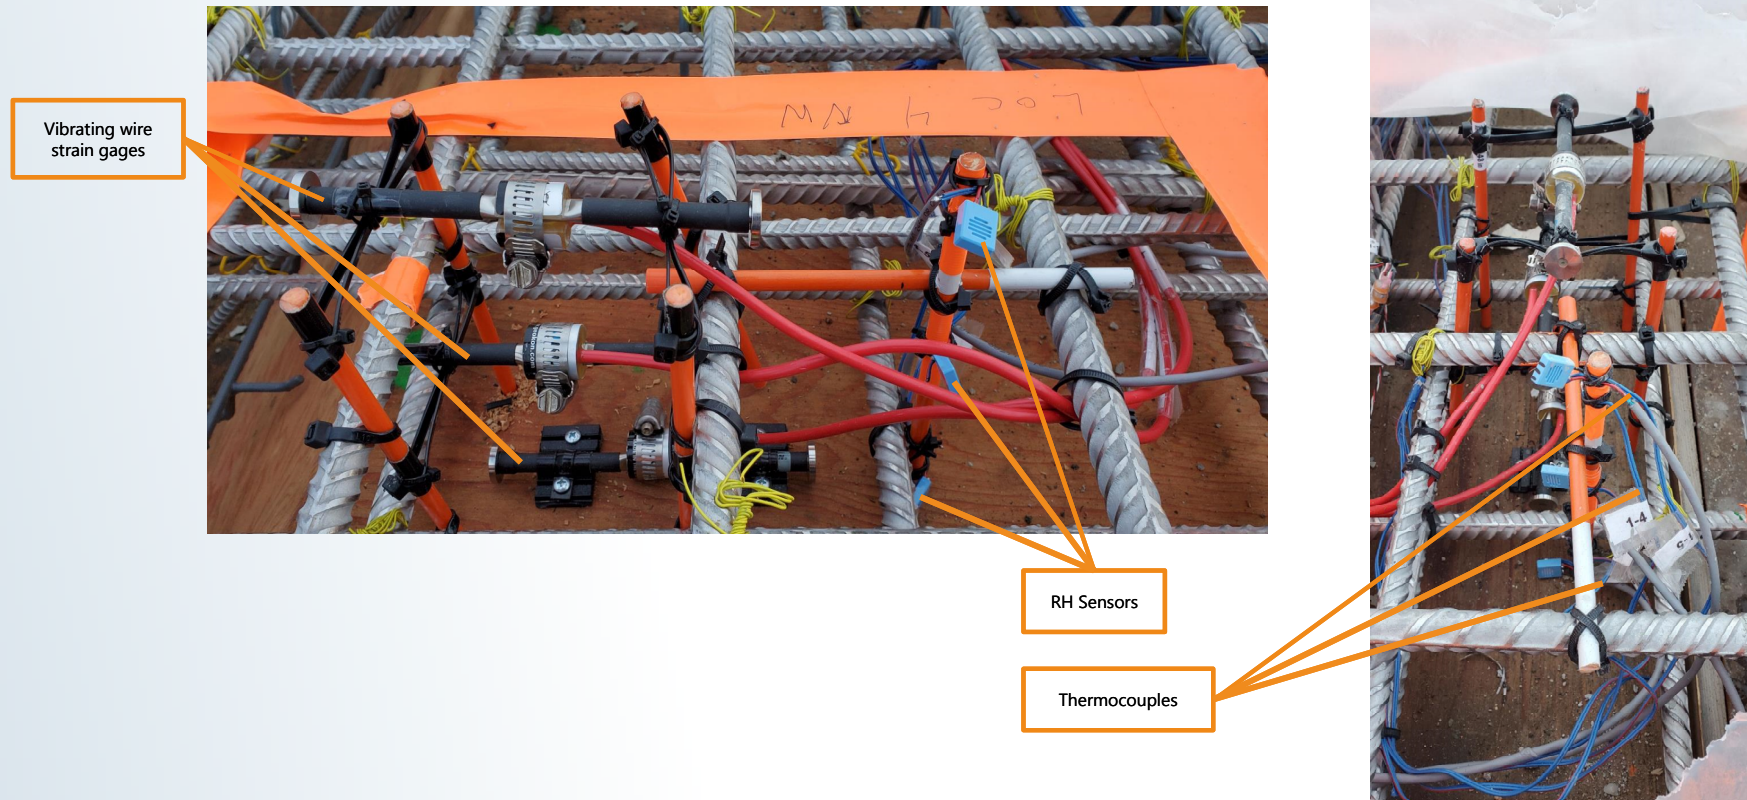
Bridge Deck Instrumentation

- Goal to understand the impact of environmental changes on the internal deck temperatures, relative humidity (RH), and strains.
- Bridge Deck Instrumented for:
 - Strain (vibrating wire SG's)
 - Temperature
 - Relative Humidity (resistive)
 - Ambient conditions – temperature, relative humidity, wind speed, and solar radiation

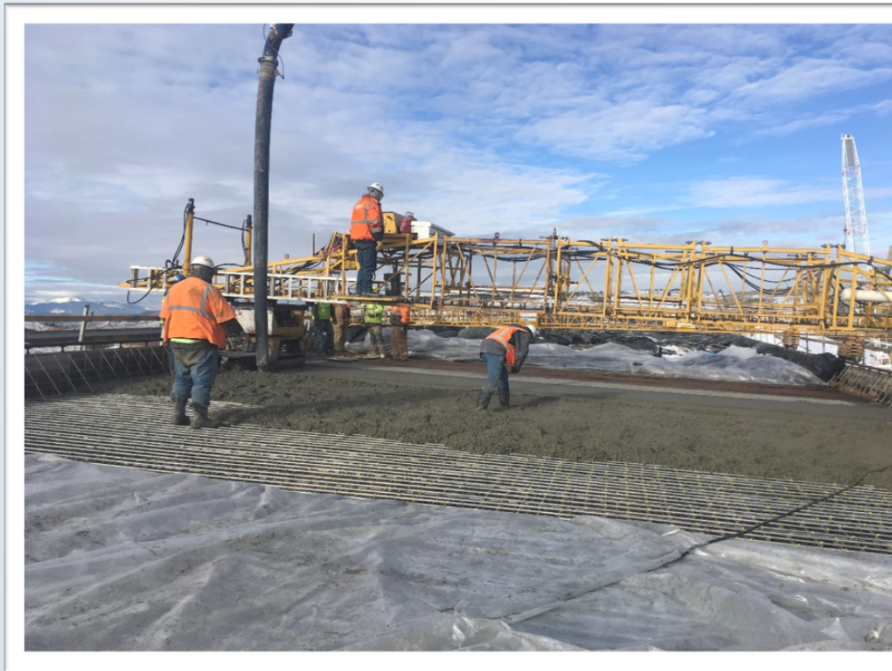
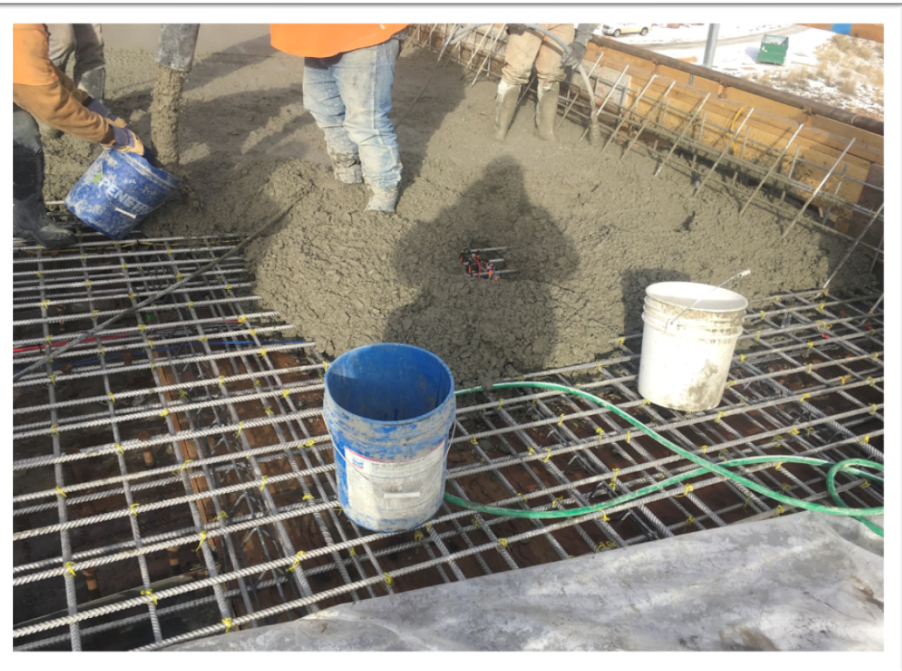
Bridge Deck Instrumentation

- Concrete Deck placement on December 5, 2019

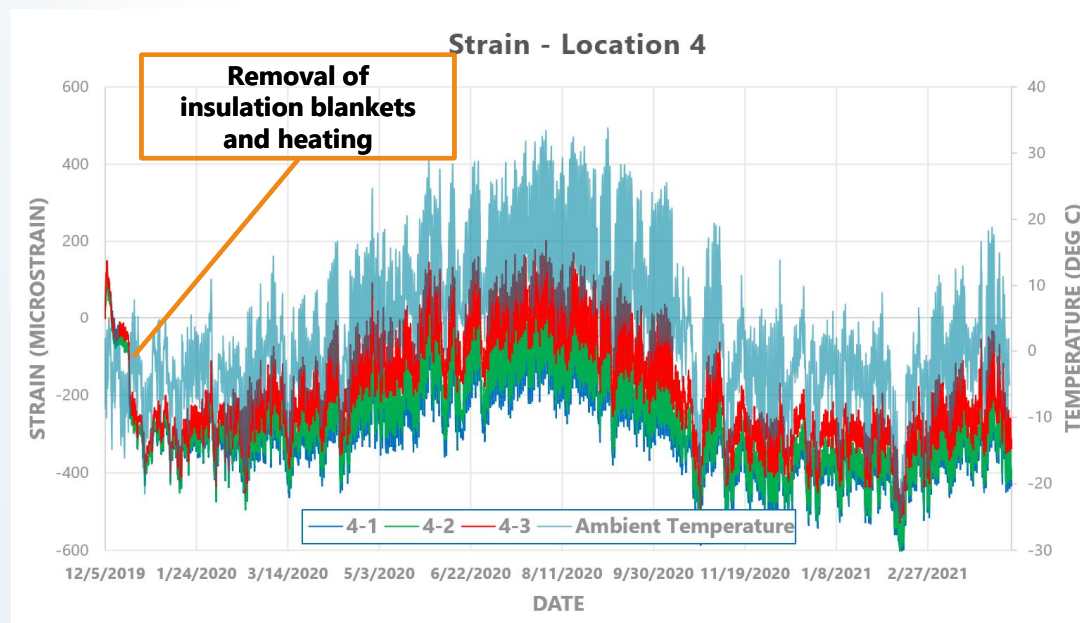
- Strain gages did not show indication of cracking (sudden change in strain)
- No tensile strains developed during the winter wet-curing methods (11 days)
- Compressive strain developed in deck after removal of insulation and heating

- None of the installed strain gages showed any indication of cracking (sudden change in strain)
- No tensile strains developed in the deck during the curing period
- Removal of heating created a pre-compression of the deck
- Large daily ambient temperature changes were recorded with extremes at 55 to 60F, creating gradients within the deck
- Large daily ambient humidity changes, creating gradients within the deck as large as 30 percent

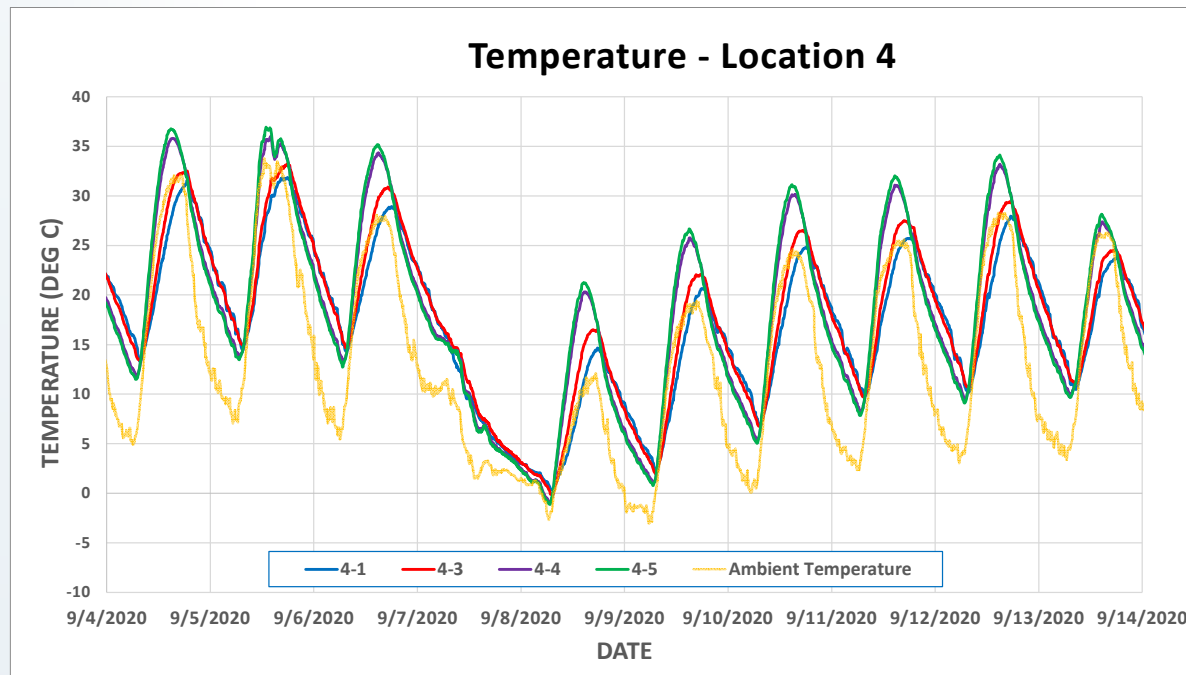
- Large daily temperature changes observed ($\Delta T = +55$ to 70°F)
- Temperature gradient within the deck, 20°F

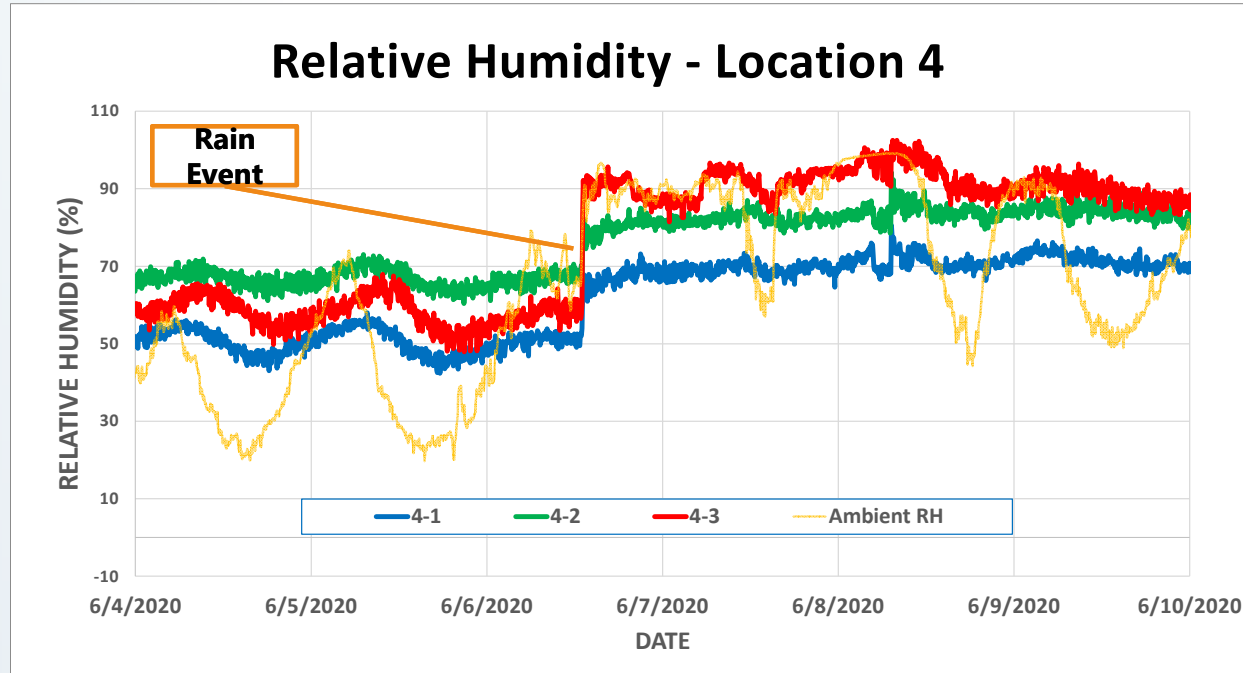
Relative Humidity

- Large daily RH changes observed
- RH gradient within the deck

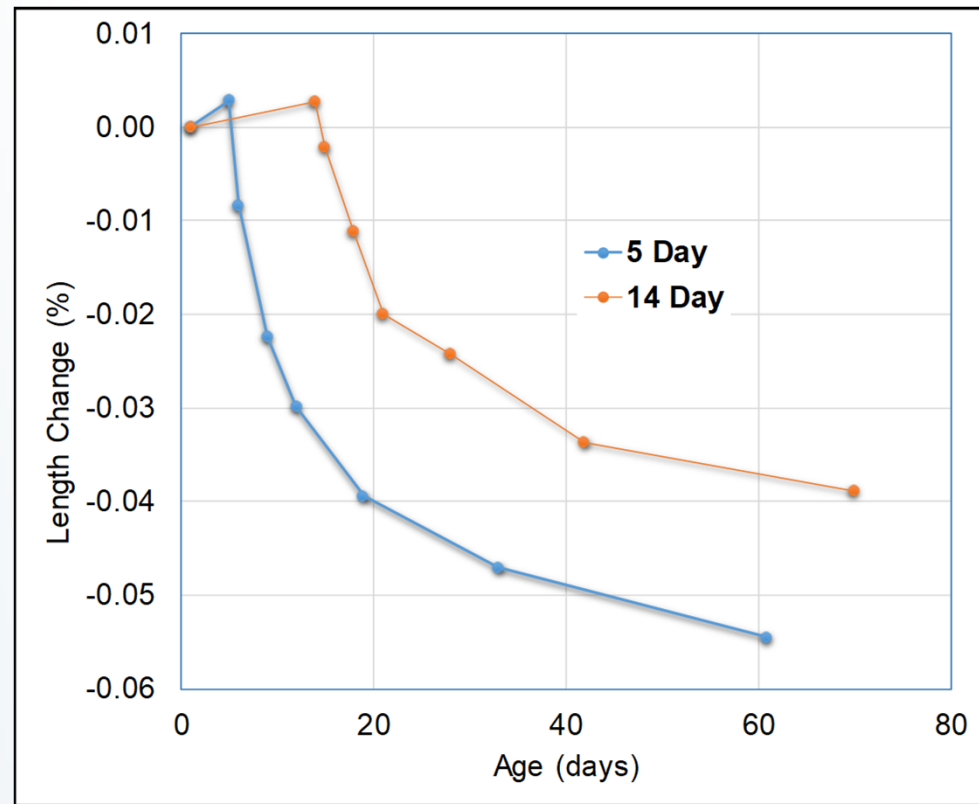
Drying Shrinkage

- Drying shrinkage significantly reduced with longer wet-curing, 5 to 14 days
- Concrete creep is greater at early ages
- Need to assess mixes for cracking potential with varying SCMs, curing periods, and for optimal curing

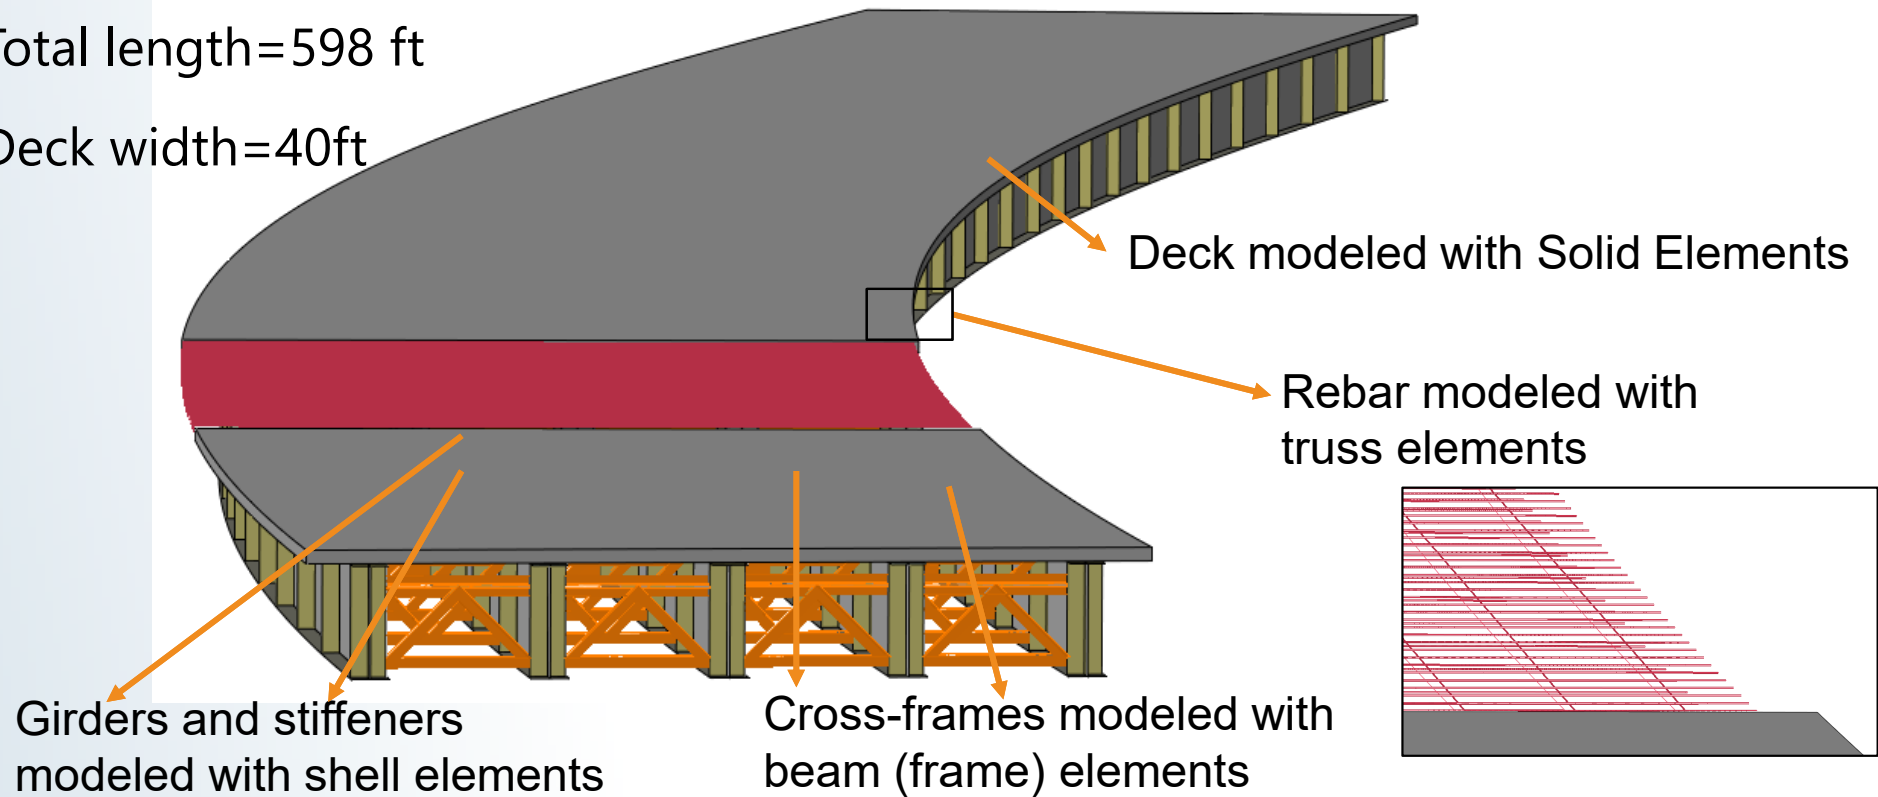
Model Assembly

- Full scale 3D Model of Rarus/Silver Bow Creek – Bridge D created in Abaqus/CAE 2020
- 4-span bridge, 5 steel plate girders with 7.75" composite deck
- Bridge superstructure is curved orienting North-South
- FE model included full-length deck geometry, girders, and lateral braces

- Total length=598 ft
- Deck width=40ft

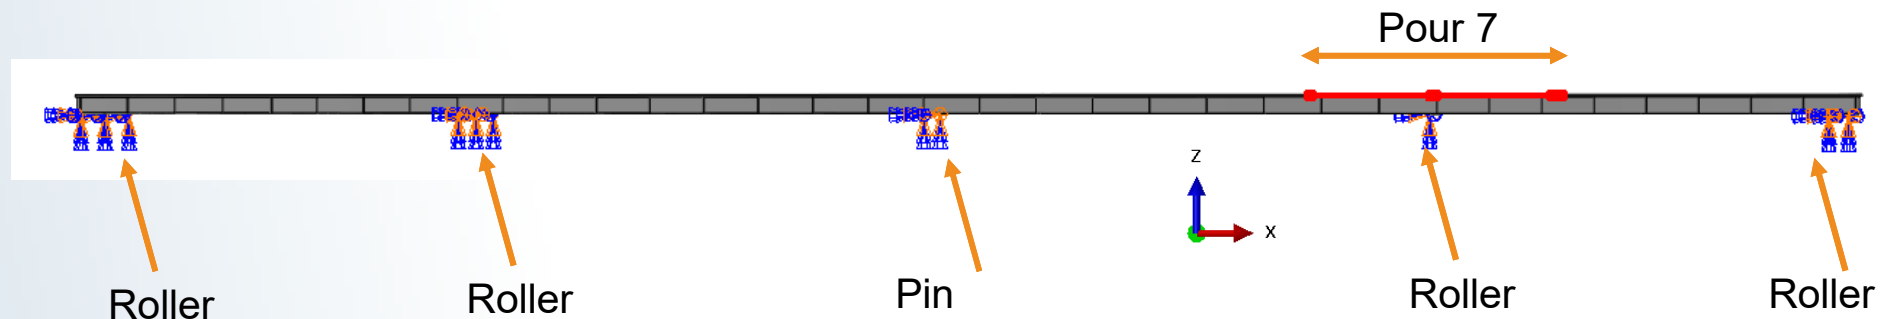
Model Interactions and Boundary Conditions

- WJE instrumentation placed at Placement No. 7 (Pour 7) region.
- Pour 7 region was modeled with refined mesh.
- Rebar elements were embedded in solid concrete elements (full bond)
- Contact with rough friction was used at concrete deck and girder interface to model composite action (no slippage allowed)

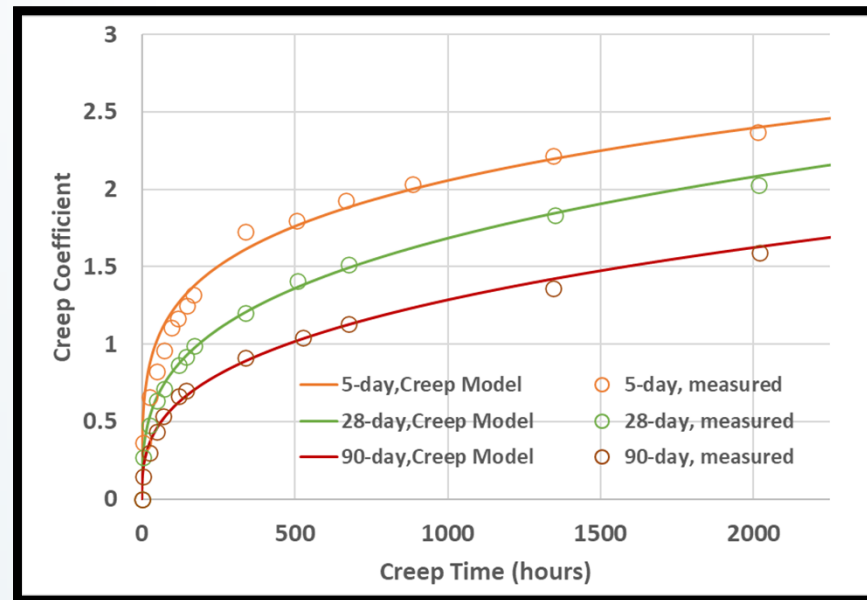
- Deck Concrete- Creep Model Calibration
 - Abaqus built-in creep model was utilized and calibrated to in-house measured creep data

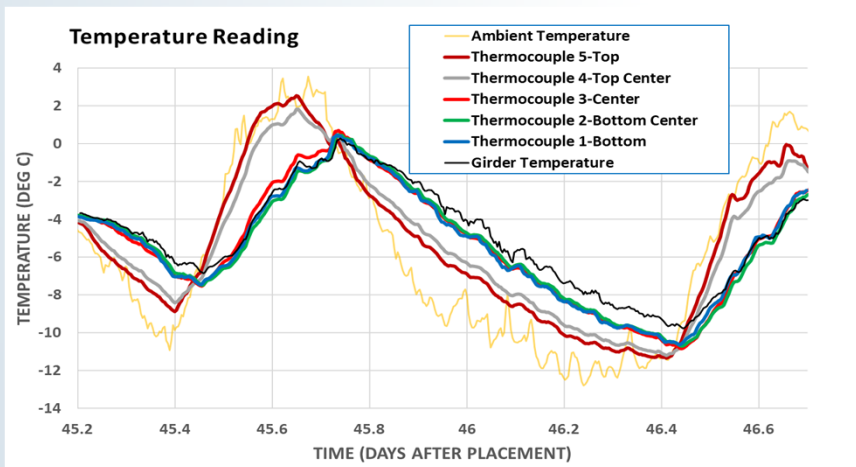
Temperature input for FE Model

- Model was validated against field-measured strain gauge data
 - The goal was to verify the global FE model trend VS. actual field behavior

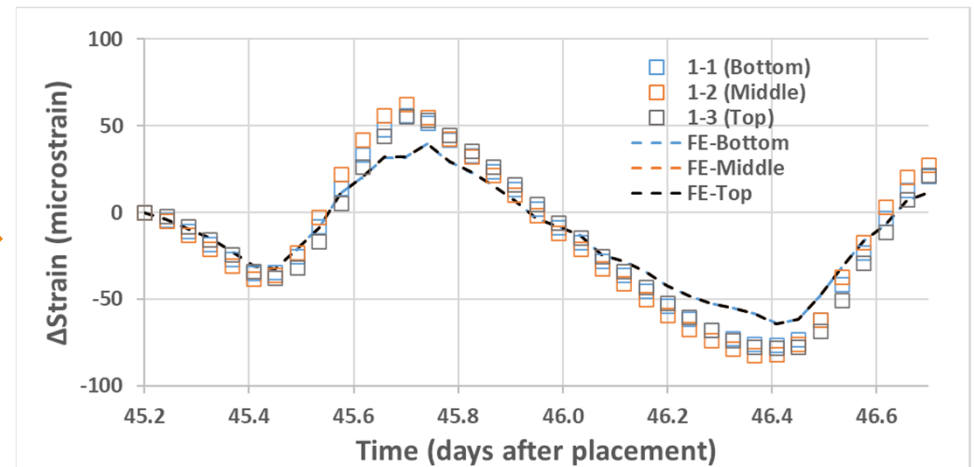
Strain output from FE Model against field-measured strain data

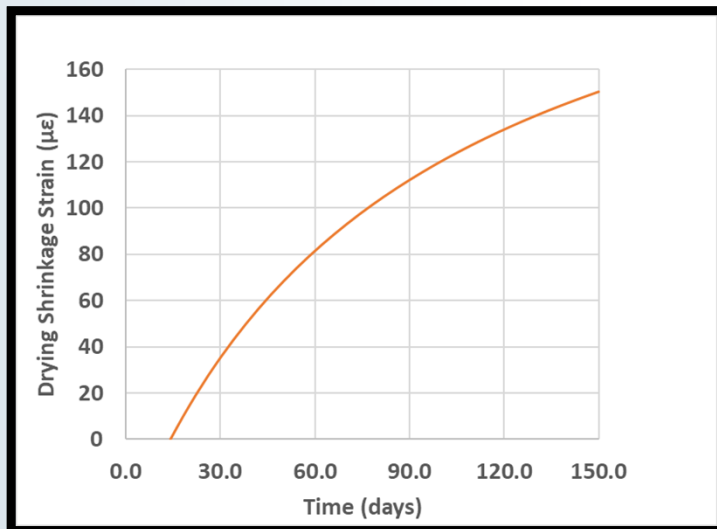
Drying Shrinkage based on ACI 209 approach

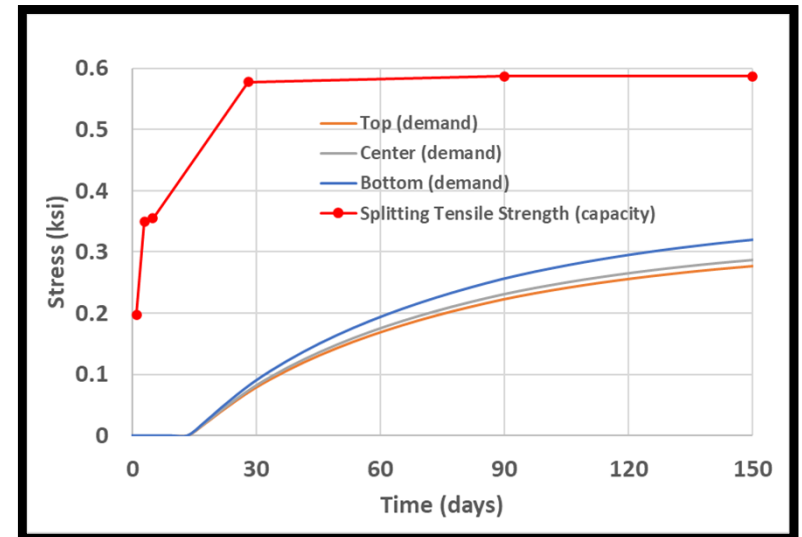
Average Resultant Longitudinal Stress vs time

- Due to restraint drying shrinkage, tensile stresses as high as 300 psi can be developed within 150 days after placement

- Drying shrinkage can contribute up to 300 psi in tensile stress, long term
- Large temperature rises can create an increase in tensile stresses by as much as 400 psi, underside of deck
- Large changes in relative humidity can create an increase in tensile stresses by as much as 300 psi, underside of deck
- The contributions from the thermal and moisture gradients can be subtractive
- Winter curing, heating from below is preferred to heating from the top

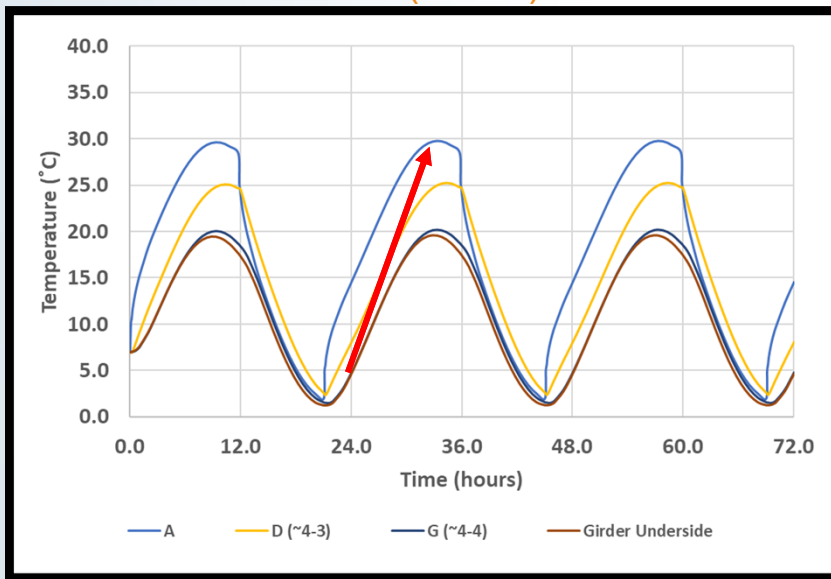
Typical simulated summer temperature with max $\Delta T = +30^{\circ}\text{C}$ ($+55^{\circ}\text{F}$)

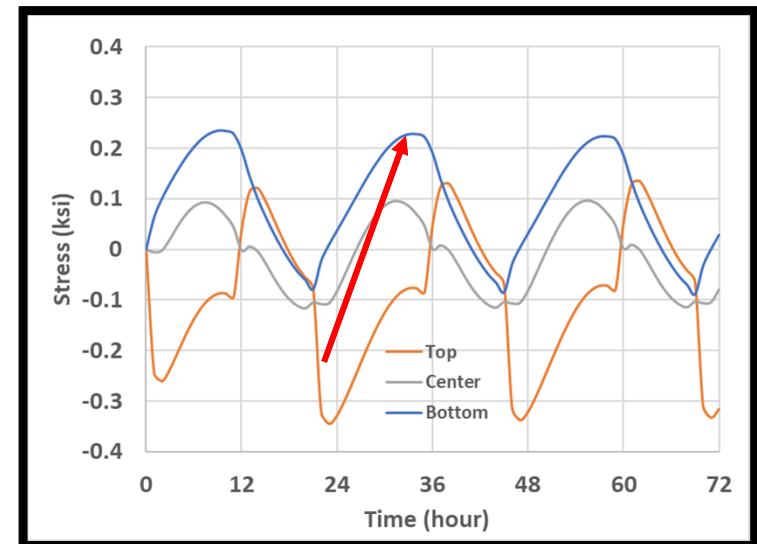
Average Resultant Longitudinal Stress vs time

- Tensile stress amplitude of 400 psi can develop due to nonlinear temperature rise

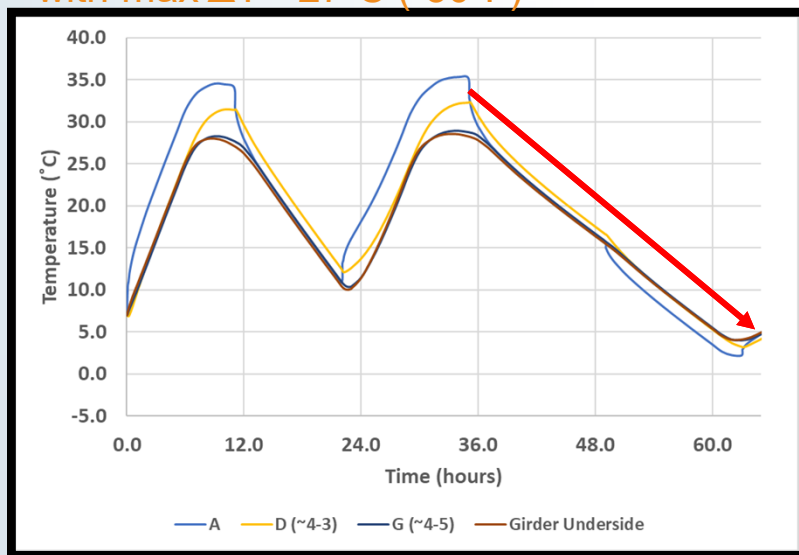
Typical simulated winter temperature with max $\Delta T = -27^{\circ}\text{C}$ (-50°F)

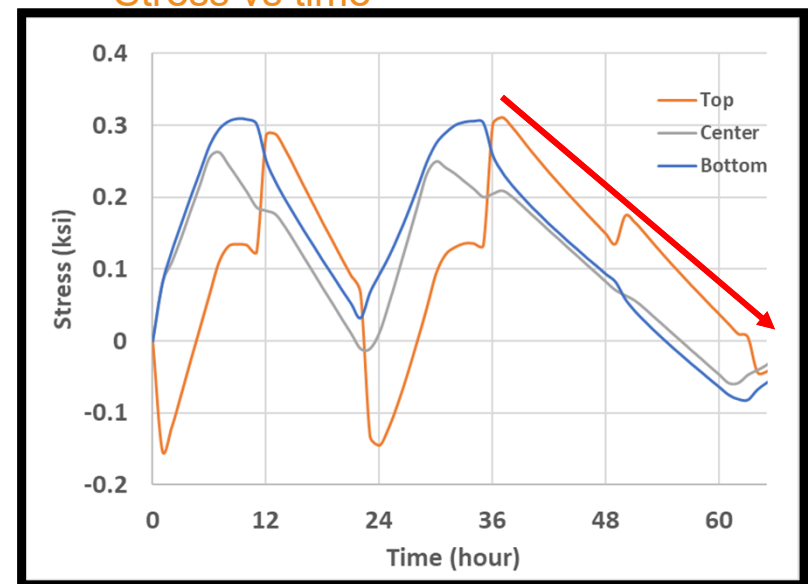
Average Resultant Longitudinal Stress vs time

- At the end of negative temperature swing, stresses are mostly compressive.

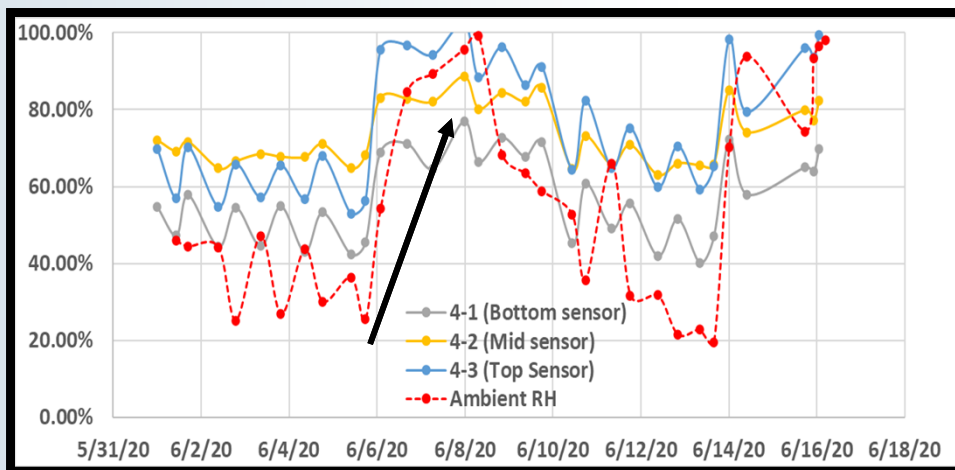
Recorded Relative Humidity at deck cross section and ambient

- Higher RH gradient existed after rain event.
- Elevated tensile stresses at the bottom of the deck.
- Combined effect of temperature and moisture gradient can be subtractive.

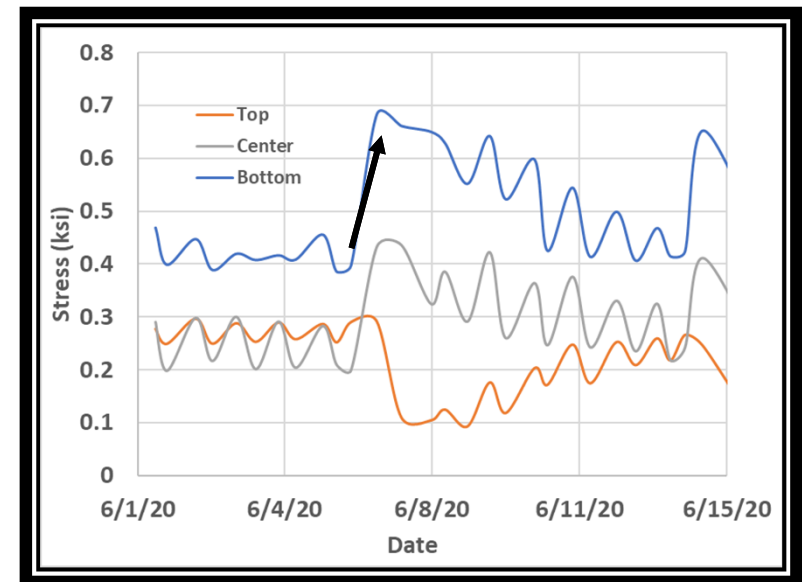
Average Resultant Longitudinal Stress vs time

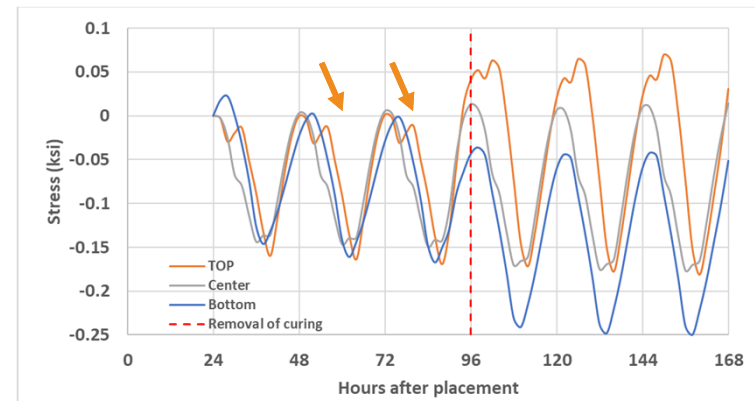
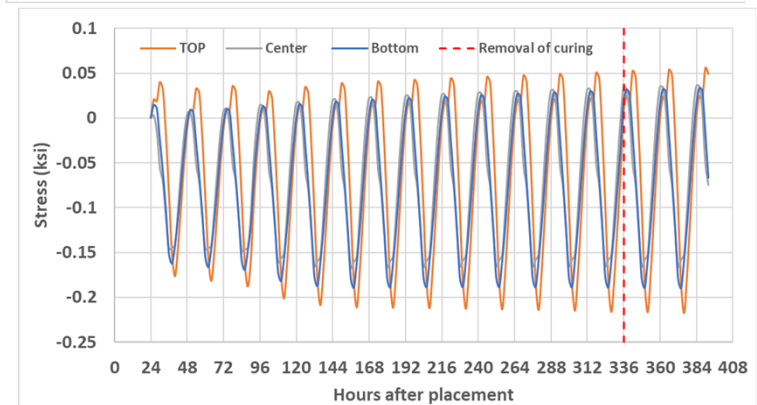
**Increase in
early age
tensile stresses
with no
insulation**

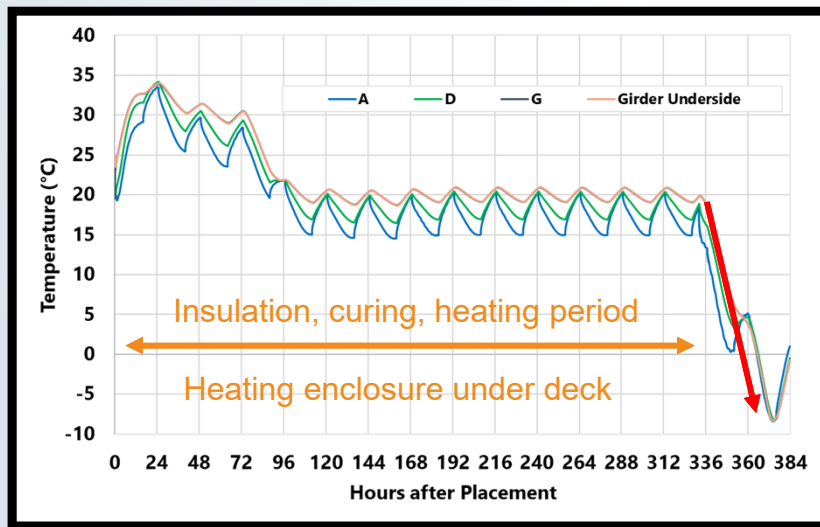
Simulated winter placement temperature

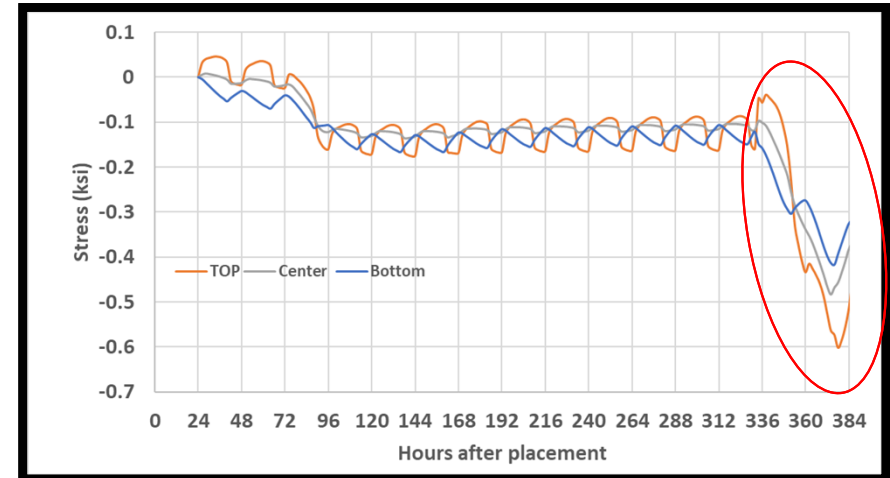
Average Resultant Longitudinal Stress vs time

- Heated from the bottom.
- No tensile stresses developed after removal of curing measures.
- Large beneficial compressive forces develop.

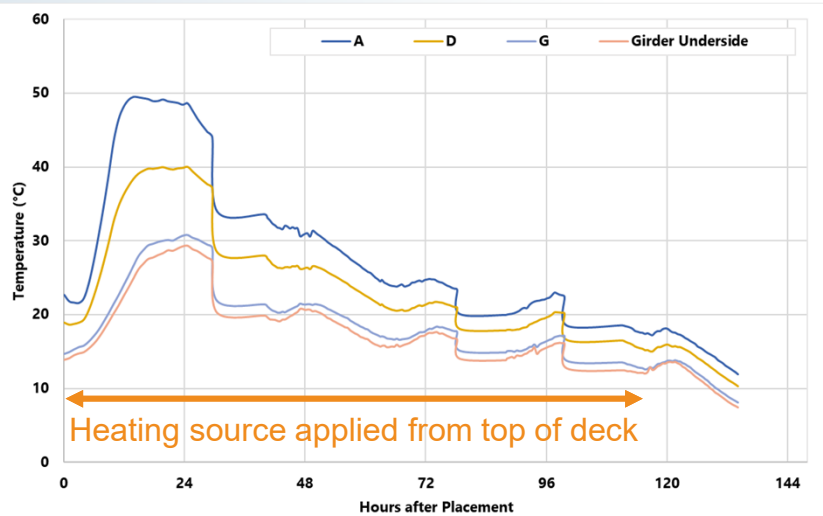
Winter placement temperature estimated from Russel street bridge

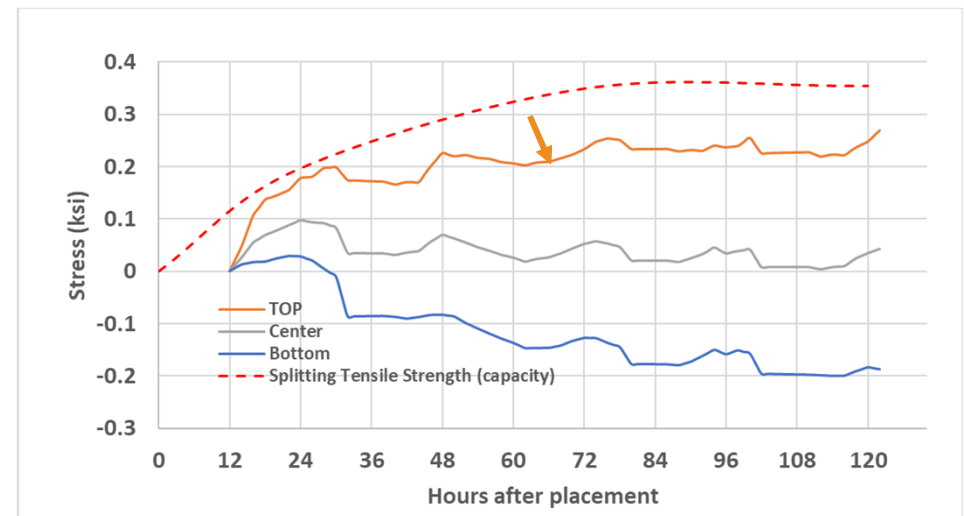
Average Resultant Longitudinal Stress vs time

- Heated from the top
- Elevated tensile stresses developed within the first few days after placement, sufficient to exceed tensile capacity.
